Cheselbourne Village Nuisance Flooding

Catchment Management Options Dr Peter Stone

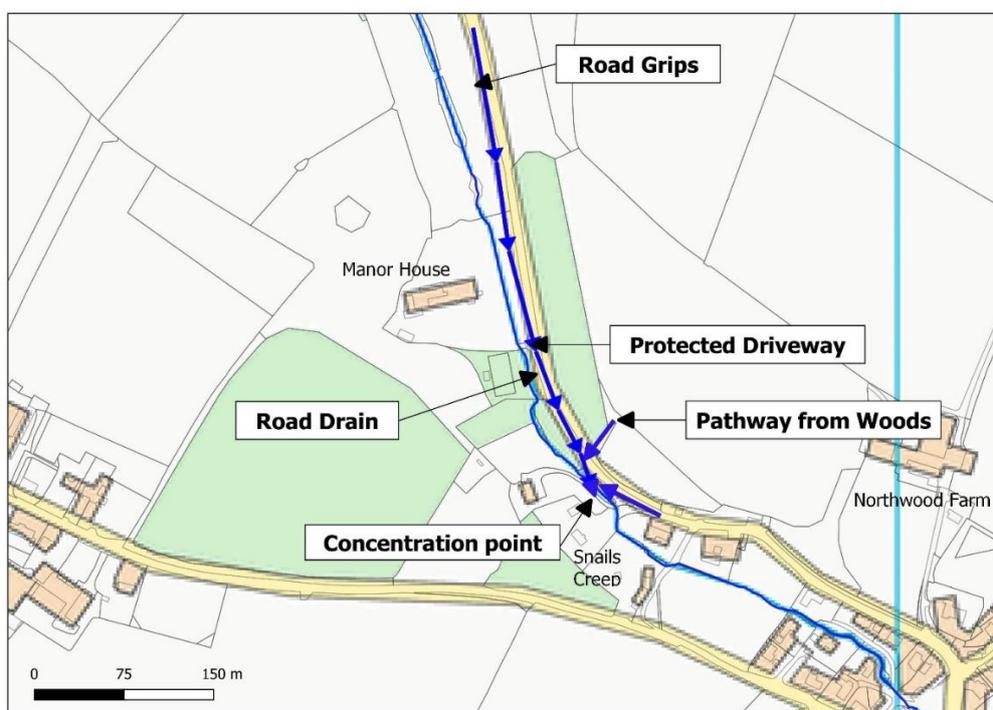
Figure 3 Surface runoff concentrating towards Snails Creep property

A concentration of road runoff occurs at the driveway entrance to Snails Creep and Aspen Barn properties (Figure 3). The runoff is largely derived from the north along the road itself and there is no evidence of connectivity to adjacent catchment slopes or fields joining the road, suggesting flow is sourced from direct runoff on the hard surface and slope of the road. One exception is a possible source from a track in the woodland to the north-west of the concentration point which joins the road (pathway from woods marked on map).

No further measures are proposed to manage the road runoff but **maintenance of the existing measures is required** to ensure the effective functioning. Specifically, the road grips that have been cut are currently ineffective where material is blocking the entrance to the grip and retaining flow along the road. It is likely the blockage occurs from mud displaced when traffic erodes the road margin. Clearance

of the grip opening to ensure the level is below the road surface is required to restore functioning.

Road drains should also be maintained to ensure debris/leaves does not gather on top of the grill and prevent drainage.

In addition to maintenance of road drainage, the potential source from the woodland area close to the point of concentration could be managed by addition of a log/tree trunk place perpendicular across the slope along the pathway to divert any runoff into the (lower level) adjacent woodland to the north.

- Maintain road grips to remove blockage and ensure the entrance is below road surface
- Keep road drain gills clear of debris
- Divert flow from along the wood pathway

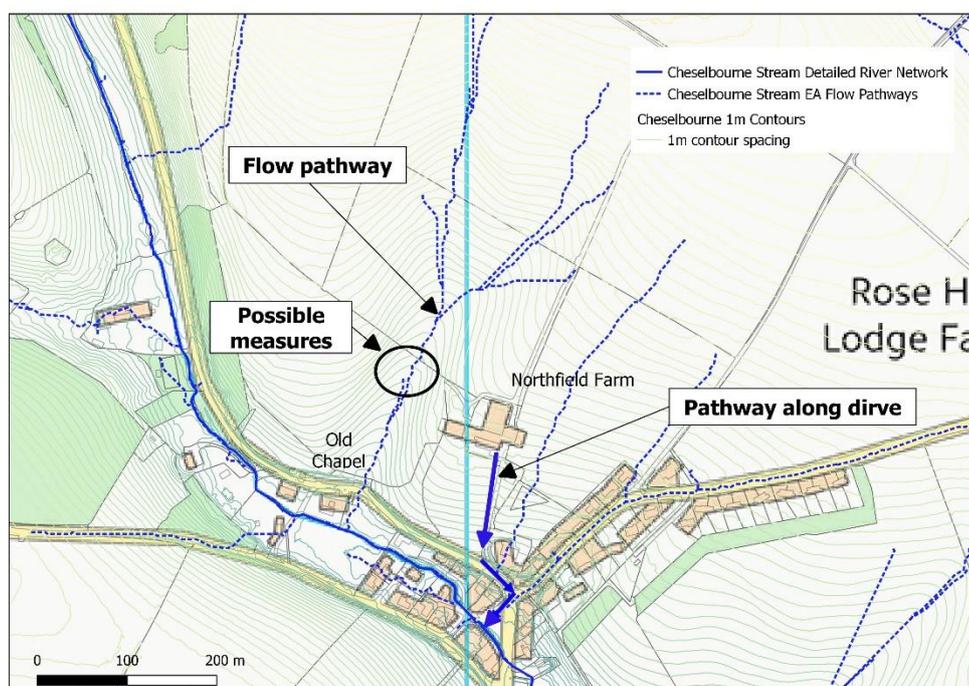
Figure 4 Surface runoff pathways at Northfield Farm

A source of runoff has been observed flowing along a newly concreted drive from Northfield Farm (Figure 4). Following initial construction of the drive surface in 2020, loose material was washed down the drive and onto the downstream road, and the hardstanding surface is an ongoing pathway for runoff. The drive provides a connected pathway down slope to the road (Figure 4), and subsequently to the Cheselbourne stream. Property at the lowest point on the road is at risk from surface water flooding.

An additional flow pathway is however identified from desk-based study which could connect to the road at The Old Chapel (blue dotted line in Figure 4). Addition of a buffer such as a hedge between fields (black circle in figure) would add a disruption to the continuity of the potential runoff pathway.

Measures have been identified to address the source of runoff generated along the farm drive. The farm is applying to Countryside Stewardship this year to remediate the problem with measures being considered including:

- Divert and collect clean water from yards;
- Installing grips to diverting water off the track;
- Woodland planting and reducing arable area through a woodland creation grant.

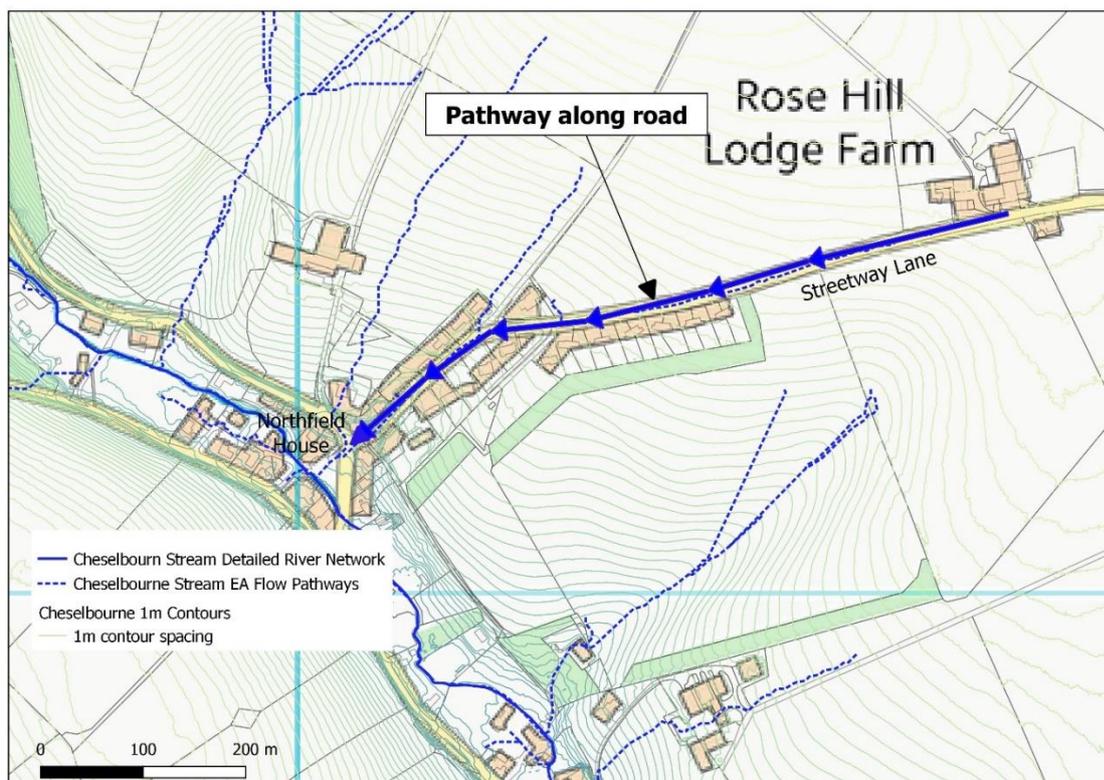
Figure 5 Surface road runoff generated along Streetway Lane

Road runoff generated along Streetway Lane flows down the road hill, crossing the road through Cheselbourne and passing Northfield House before joining the Cheselbourne stream (Figure 5). The runoff is generated approximately 700m up hill from the road junction with some of the source derived from Rose Hill Lodge Farm along with direct runoff along the road surface.

The road drainage along the road is currently managed with 7 road drains. During the walkover survey, most of the drains were clear although some had debris and mud surrounding them that will reduce their effectiveness. The gully pots in most of the drains contained sediment, with some

pots filled. No further measures are proposed to manage the road runoff but **maintenance of the existing road drain measures is required** to ensure the effective functioning. Notably, road verge erosion and mud washed along the road are likely to block the grills of the drains. **The grills of the drains should be kept clear as regularly as possible.**

Drainage management of the farm yard at Rose Hill Lodge Farm can be improved to reduce direct connectivity to the road. Runoff and sediment generated at the farm is currently washed on to the road and transported down slope.

- Keep road drain gills clear of debris;
- Reduce connectivity of farm yard drainage to the road.

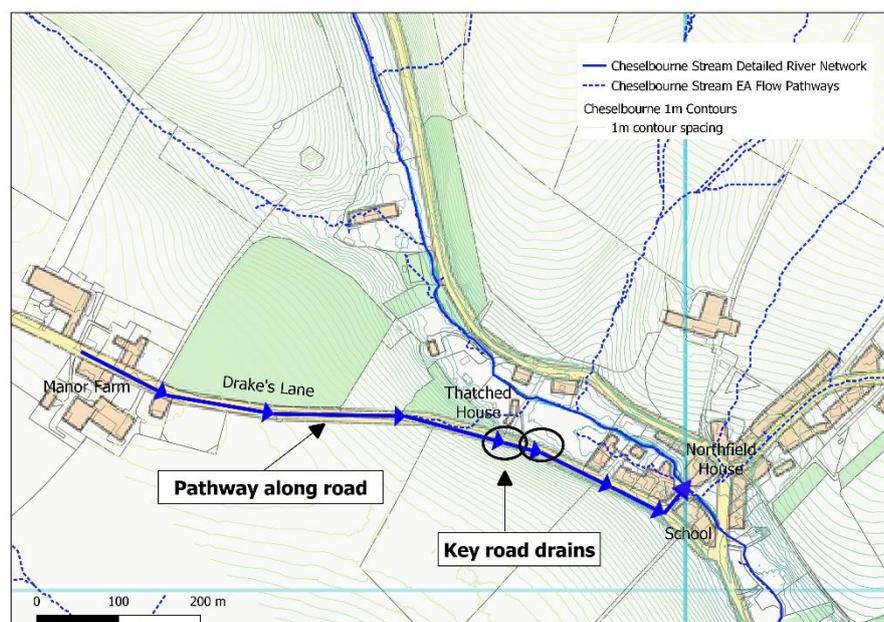
Figure 6 Road runoff generated along Drake's Lane

Road runoff generated along Drake's Lane, in the vicinity of Manor Farm, flows down the road slope towards Cheselbourne village and diverts off the road along a track behind the village school towards Northfield House (Figure 6). Flooding has previously occurred where the runoff is unable to drain into the Cheselbourne Brook.

The runoff does not appear to be generated from the upstream farm and there is no evidence of connectivity of flow from adjacent fields joining to the road. The runoff represents surface water concentrated along the hard surface which is confined along the pathway of the road. Erosion of the roadside verge from traffic at the margins of the road is adding mud and sediment to the fringes, which is in turn washed down slope in the runoff.

Two key road drains at the entrance driveway to the Thatched Cottage are key to intercepting the runoff. The upslope road drain is correctly located within the runoff pathway and clearly traps silt washed along the road; during the site visit on 21st January the gully pot was full with trapped sediment. The **grill of the drain is kept clear** by volunteers and needs ongoing maintenance. The drains downslope of the drive are functioning but material eroded from the roadside verge immediately before the drain has **potential to deflect runoff flow away from the drain**.

- Continue to keep the grill of the road drain upstream of the Thatched Cottage drive clear of debris;
- Maintain connectivity of the downstream road drain by clearing back material eroded onto the road.

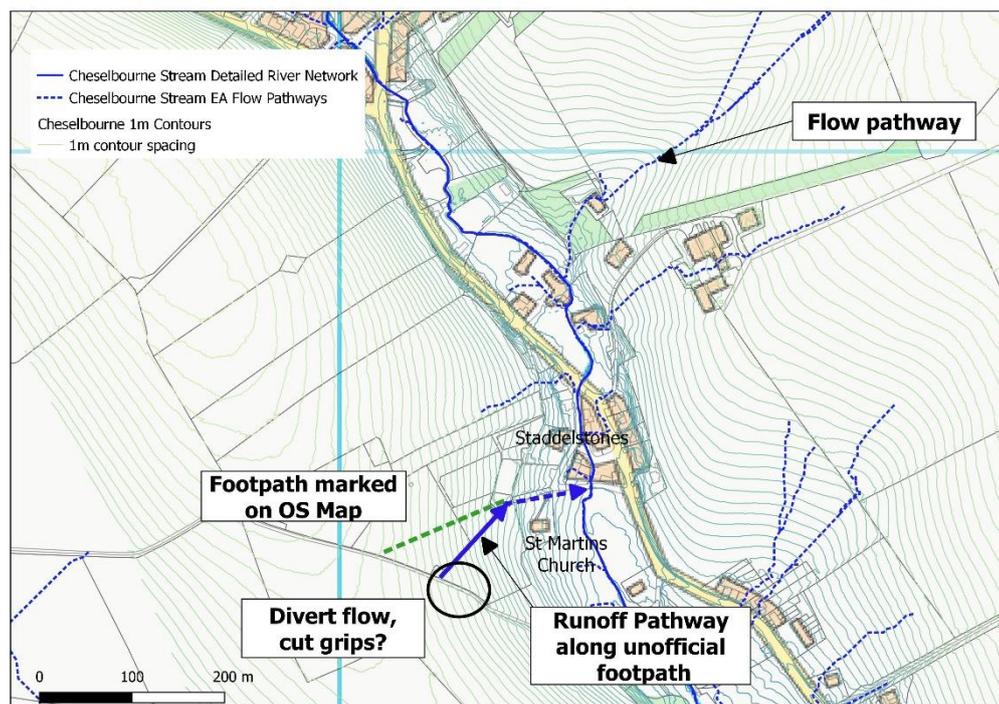
Figure 7 Surface runoff from catchment slopes concentrating towards Stadelstones

Surface runoff generated from catchment slopes to the west of St Martins Church is concentrated into a pathway that runs along a public footpath which follows to the stream by Staddelstones (Figure 7). There are signs of runoff erosion along the footpath which concentrates flow downslope towards Staddelstones property.

No obvious connectivity or source of runoff was identified during the site visit which links to specific field or farming practices. The tracks and footpaths are likely to provide pathways for runoff to generate.

Two options to break the flow pathway are proposed; installation of a **shallow bund** at the top of the footpath to divert flow along the track (and cutting grips into the field behind the church if necessary), or **relocation of the footpath**.

The Ordnance Survey map may be out of date, but the footpath from the Church up slope appears located centrally through fields, rather than along the boundary. **Reinstating the path** to a diffuse route through the field rather than a concentrated narrow passage will help to reduce concentration of flow.

- Disrupt the flow pathway on the slopes above the Church by shallow bunding the top entrance to the footpath or diverting the footpath.

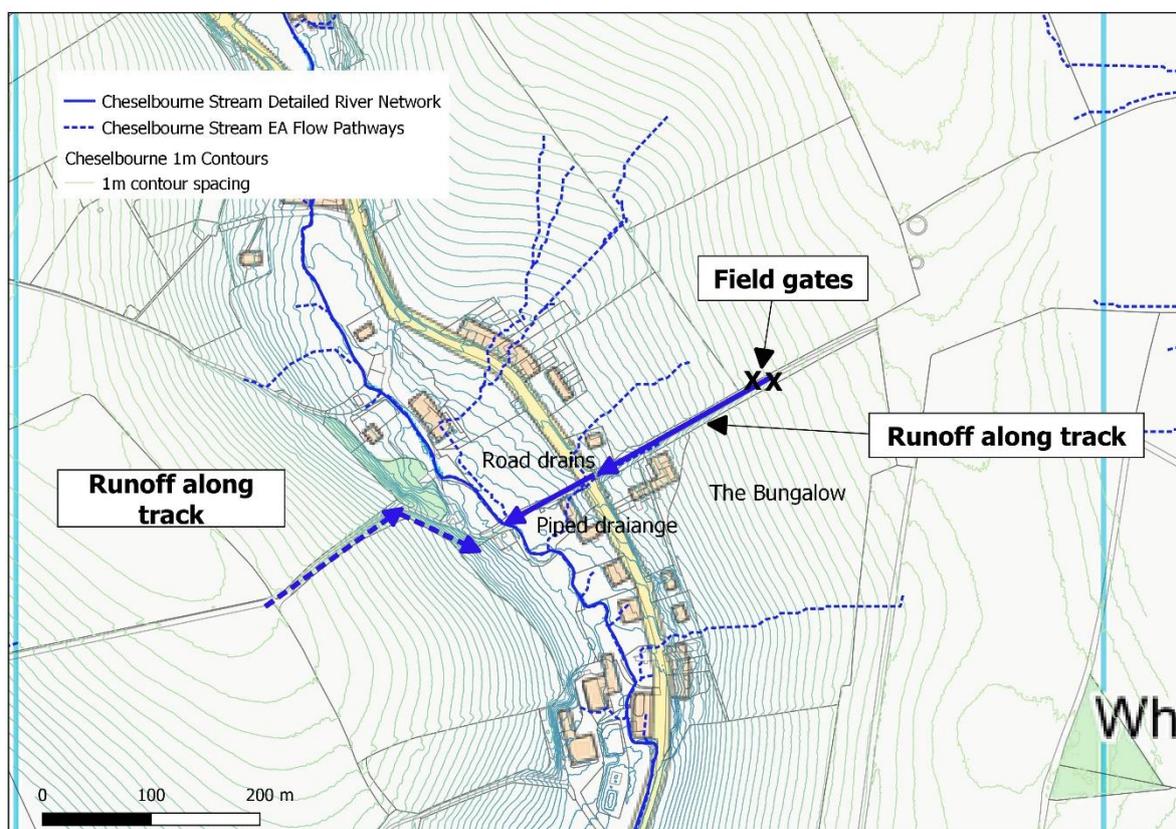
Figure 8 Flow pathways at the ford location in the south of Cheselbourne village

Two pathways of runoff have been observed in the south of Cheselbourne village, both draining to a ford crossing of the Cheselbourne stream (Figure 8). The western pathway is along a track/footpath and flows through an incised passageway over bedrock. There do not appear to be any connected fields which are sources of runoff and it is concluded that surface water from direct rainfall concentrates along the hard surface with no opportunity for drainage or diffusion. No obvious mitigation measures were identified to reduce the runoff.

Runoff generated along the track to the east flows along a concentrated pathway in a track, down a steep slope and crosses the road. Road drains on the downslope side of the road intercept some runoff which then flows in a buried pipe towards the Cheselbourne stream. Anecdotal evidence suggests the pipe may get blocked (with sediment) such that a manhole cover along the pipe route surcharges.

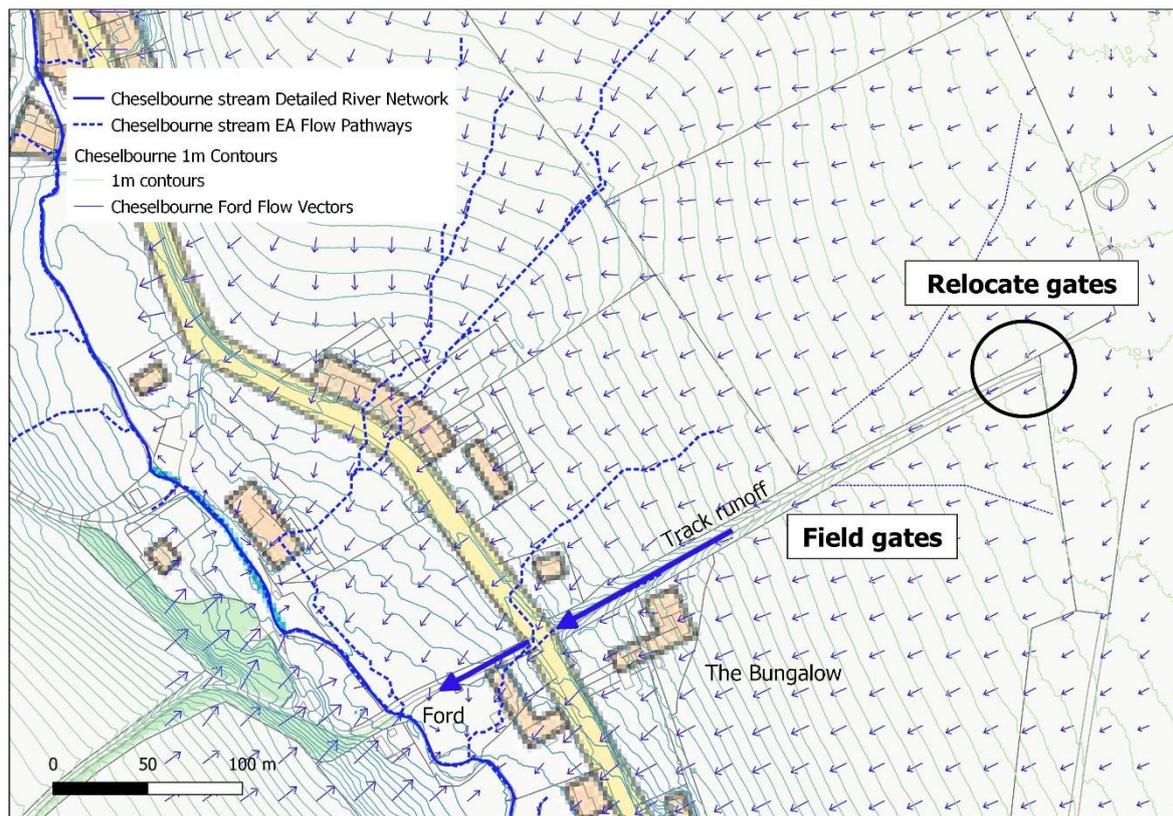
Figure 9 Runoff flow directions generated in fields draining to the ford.

Runoff from two arable fields adjacent to the eastern track appears to be connected to the track through gateways which are accessed from the track on either side. It is likely that runoff and sediment generated from the fields is transported towards the Cheselbourne stream. Measures to address the pathway of runoff from the fields are likely to reduce the impact on the road and stream.

Within field, runoff that is to gates adjacent to the track is likely to follow the direction of the arrows shown in Figure 9. There are areas within each of the fields that concentrate flow from the field slopes towards the current location of the field gates (fine dotted line in the figure). To reduce the runoff along the track and break the connectivity from the source fields, it is proposed to **move the field gates** to the top of the slope where they will capture less flow from within the field. Operationally for farming there appears to be sufficient space and width along the track to access both fields at a point up slope. It is however noted that there is a change in surface along the track up slope from the current gate locations and confirmation will be required that the track surface is suitable for farm machinery.

- Move field entrance gateways to the top of the slope to disrupt connectivity for runoff and sediment generated within the fields.

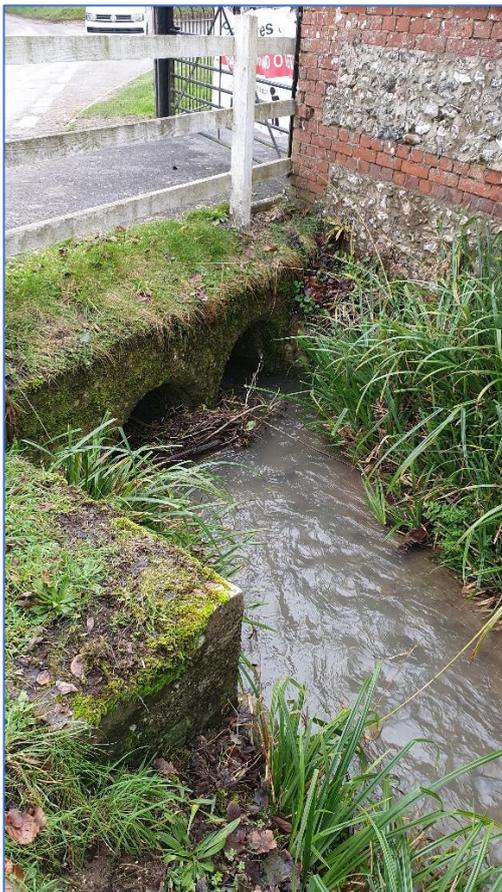
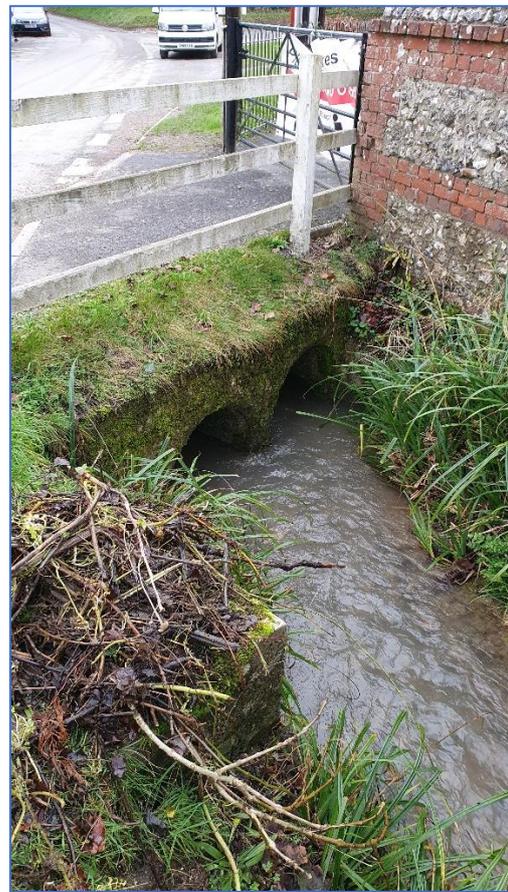
It was noted that there are a number of piped culverts along the route of the Cheselbourne stream through the village. These piped culverts are often of low capacity or diameter and are likely easily blocked by natural debris that floats down the channel combined with consolidation with sediment. Maintenance of the pipe entrances is necessary to ensure passage of flow and minimise backing up of flow and associated out of bank flooding during spate events.

It is likely that there will be an initial flush of material accumulated during the summer at the start of the winter when flow builds up in the channel as groundwater levels rise. However, material will be transported throughout the winter, and checks and maintenance should be carried out as frequently as possible.
