Cheselbourne Village Nuisance Flooding

Catchment Management Options Dr Peter Stone

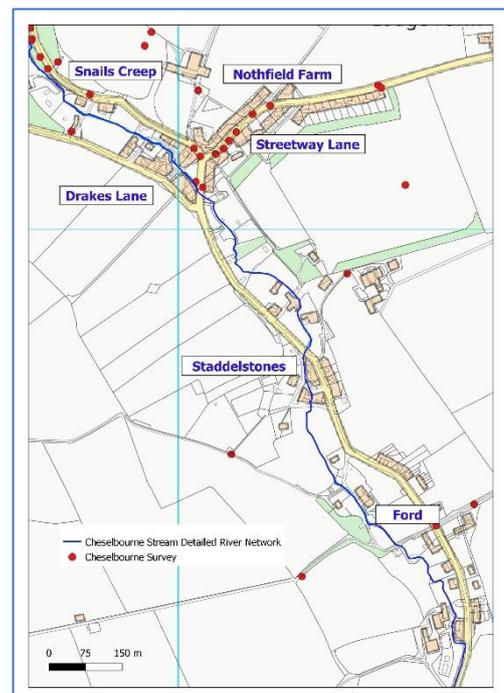
Figure 2 Observations recorded during walkover survey

The primary aim of the walkover was to attempt to identify the source of runoff but also the pathway which connects the runoff to the downstream receptor and the stream. Understanding the connecting pathway is particularly important, and observations were recorded of both natural and modified drainage. Locations of recorded observations are shown in Figure 2.

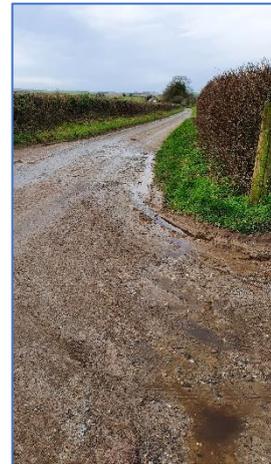
The road drainage along the road is currently managed with 7 road drains. During the walkover survey, most of the drains were clear although some had debris and mud surrounding them that will reduce their effectiveness. The gully pots in most of the drains contained sediment, with some

pots filled. No further measures are proposed to manage the road runoff but **maintenance of the existing road drain measures is required** to ensure the effective functioning. Notably, road verge erosion and mud washed along the road are likely to block the grills of the drains. **The grills of the drains should be kept clear as regularly as possible.**

Drainage management of the farm yard at Rose Hill Lodge Farm can be improved to reduce direct connectivity to the road. Runoff and sediment generated at the farm is currently washed on to the road and transported down slope.

- Keep road drain gills clear of debris;
- Reduce connectivity of farm yard drainage to the road.

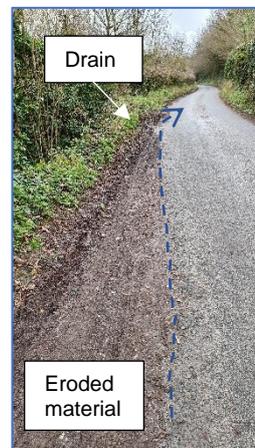
Two key road drains at the entrance driveway to the Thatched Cottage are key to intercepting the runoff. The upslope road drain is correctly located within the runoff pathway and clearly traps silt washed along the road; during the site visit on 21st January the gully pot was full with trapped sediment. The **grill of the drain is kept clear** by volunteers and needs ongoing maintenance. The drains downslope of the drive are functioning but material eroded from the roadside verge immediately before the drain has **potential to deflect runoff flow away from the drain**.

- Continue to keep the grill of the road drain upstream of the Thatched Cottage drive clear of debris;
- Maintain connectivity of the downstream road drain by clearing back material eroded onto the road.

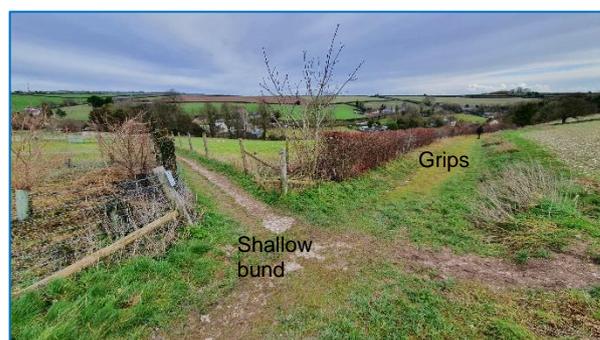
Figure 7 Surface runoff from catchment slopes concentrating towards Stadelstones

Surface runoff generated from catchment slopes to the west of St Martins Church is concentrated into a pathway that runs along a public footpath which follows to the stream by Staddelstones (Figure 7). There are signs of runoff erosion along the footpath which concentrates flow downslope towards Staddelstones property.

No obvious connectivity or source of runoff was identified during the site visit which links to specific field or farming practices. The tracks and footpaths are likely to provide pathways for runoff to generate.

Two options to break the flow pathway are proposed; installation of a **shallow bund** at the top of the footpath to divert flow along the track (and cutting grips into the field behind the church if necessary), or **relocation of the footpath**.

- Disrupt the flow pathway on the slopes above the Church by shallow bunding the top entrance to the footpath or diverting the footpath.

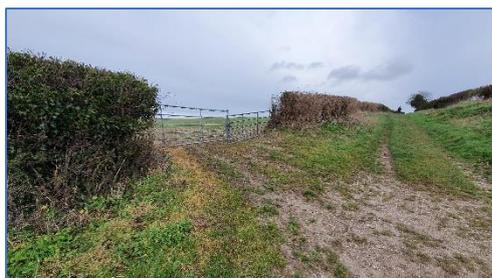
Figure 9 Runoff flow directions generated in fields draining to the ford.

Runoff from two arable fields adjacent to the eastern track appears to be connected to the track through gateways which are accessed from the track on either side. It is likely that runoff and sediment generated from the fields is transported towards the Cheselbourne stream. Measures to address the pathway of runoff from the fields are likely to reduce the impact on the road and stream.

Within field, runoff that is to gates adjacent to the track is likely to follow the direction of the arrows shown in Figure 9. There are areas within each of the fields that concentrate flow from the field slopes towards the current location of the field gates (fine dotted line in the figure). To reduce the runoff along the track and break the connectivity from the source fields, it is proposed to **move the field gates** to the top of the slope where they will capture less flow from within the field. Operationally for farming there appears to be sufficient space and width along the track to access both fields at a point up slope. It is however noted that there is a change in surface along the track up slope from the current gate locations and confirmation will be required that the track surface is suitable for farm machinery.
